Permanent media filter proves itself in a competitive environment in Japan

by Shoichi Suzuki - Sanmei Kasei Co., Ltd.
and Clem Traut - SERFILCO, Ltd.

Toyohashi Plating Co., Ltd. of Toyohashi City, Japan, is a job shop plater for the automotive industry. It is a progressive company, always open to new ideas and innovations. Since the company plates in the automotive industry which is very competitive, it is essential to maintain the highest quality and the lowest cost possible, especially for customers such as Toyota, Honda and Minolta.

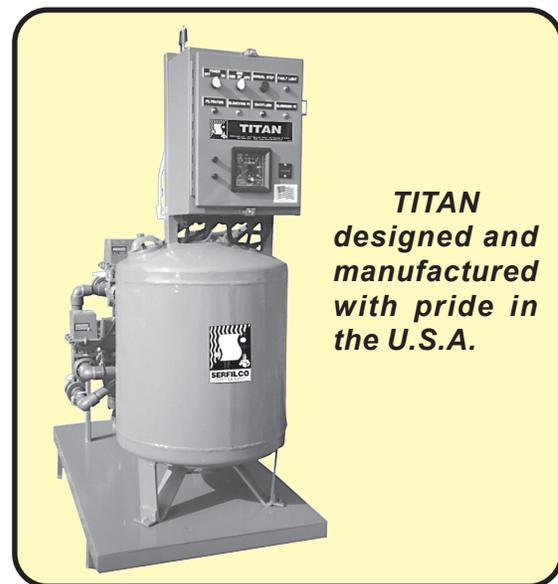
The unit, Model P60A, is rated at 13,600 LPH (3,600 GPH). It was installed on a 10,000 liter (2,642 gallon) eight barrel acid zinc chloride plating tank. Goals for the installation of the TITAN system were:

Operation of the TITAN is completely automatic and in spite of the high dirt load, the system consistently maintains a high average flow rate of 90-95% of the initial flow. When the flow rate is reduced by compacted media, the automatic backwash takes over and the unit is returned to full flow in a matter of minutes. (See chart on previous pages.)
